**SAS Superstructure**

Location: 04-SF-80-13.2 / 13.9

**Daily Diary Report by Bid Item**

Diary #: 146 Const Calendar Day: 384 Date: 27-Sep-2010 Monday

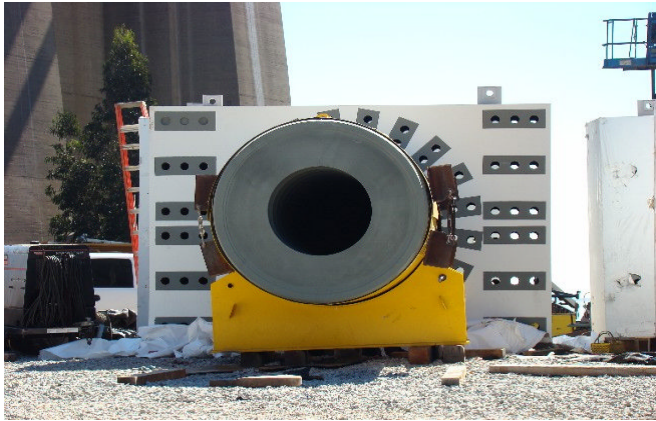
Wrapping on the first Hinge K pipe beam (HKPB) base plate was removed in preparation for erection.

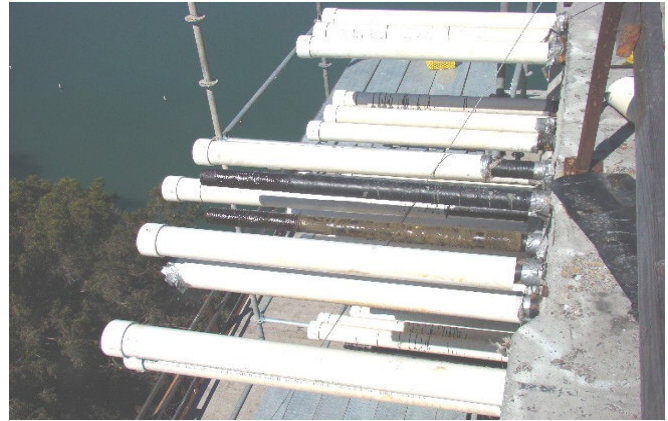
ABF ironworkers and laborers began to remove the Denso tape from the Macalloy rods and clean the concrete surface at the North W2W Hinge K.

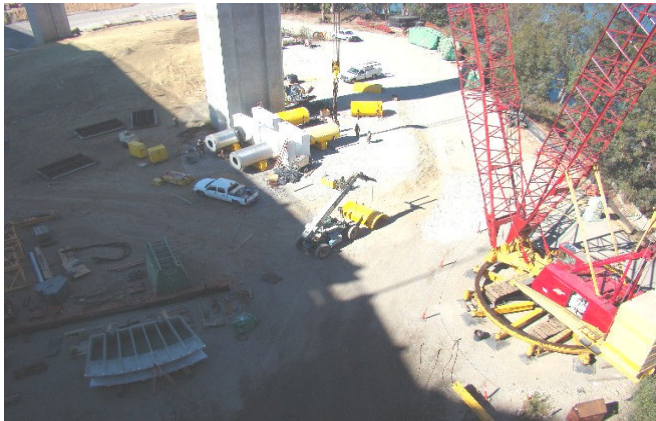
- Prepped the surface for painting the fourth and final Hinge K pipe and then applied the two coats of Zinc paint with the spray gun. See Warren Collins diary for more details regarding the paint quality and application.

Certified Coatings in the process of painting the beveled end of the fourth Hinge K pipe beam and ABF placing a protective cover on the second HKPB.

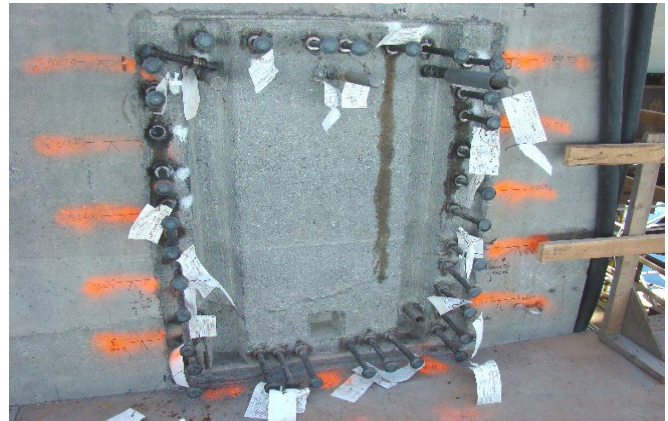
- Began to use a "thread-chaser" to clean and rethread the female couplers in the lower bikepath pedestal blockout located on the southeast end of the W2 cap beam. After the couplers were rethreaded the ironworkers would clean the female couplers with a hand grinder and WD40 prior to placing the male coupler into the female coupler in preparation for applying torque to the rebars. There were a total of 8 female couplers that needed to be rethreaded.

Male couplers with T-Heads for the lower bikepath pedestal blockout located on the southeast end of the cap beam.
